TECHNICAL REPORT ARCCB-TR-02016

CHARACTERIZATION OF EXPLOSIVELY BONDED AND FIRED TANTALUM LINERS APPLIED TO 25-MM GUN TUBES

NOVEMBER 2002

US ARMY ARMAMENT RESEARCH,
DEVELOPMENT AND ENGINEERING CENTER
Close Combat Armaments Center
Benét Laboratories
Watervliet, NY 12189-4000

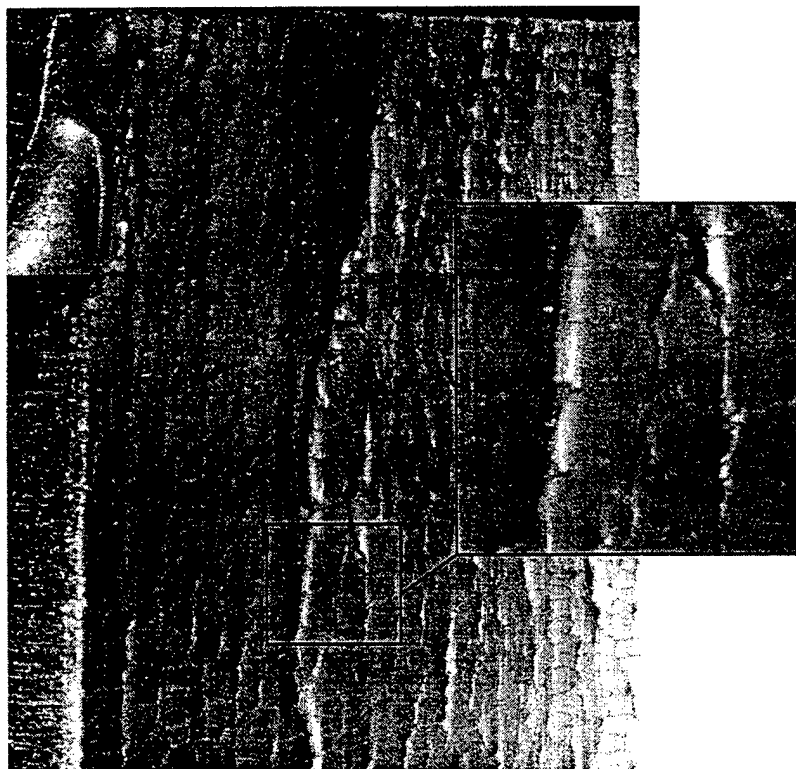
The most predominant erosion patterns of Tube B were readily distinguishable with visual and stereomicroscopic examination. Heavy heat-checking and thermomechanical/thermochemical damage of the coating is evident at the 6- to 10-inch location, along with the development of deep erosion troughs that extend well into the steel (Figures 3 and 4).

Figure 3. Severe heat-checking and gas erosion exhibited at the 6.5-inch location of Tube B.

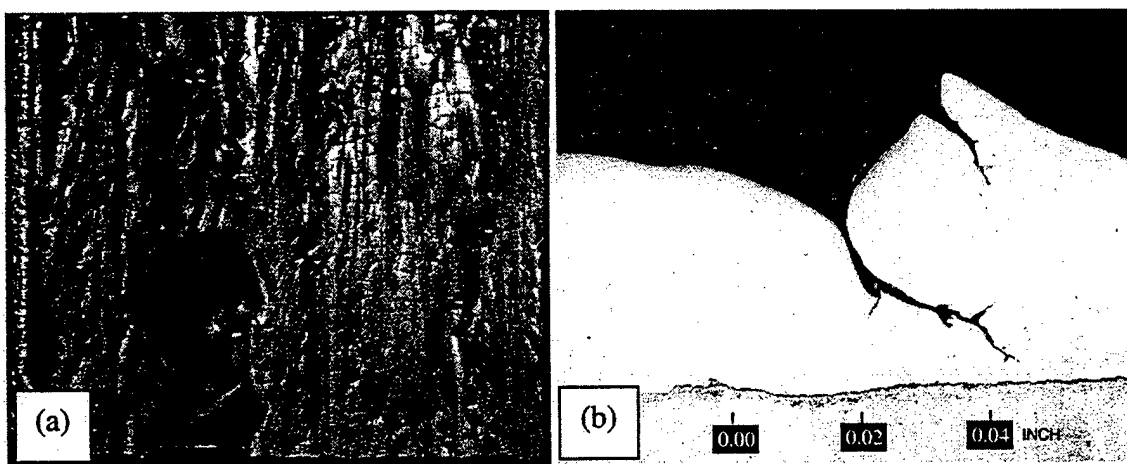
Figure 4. (a) Severe heat-checking and gas erosion exhibited at 8 inches from the rear face of the tube (RFT), and (b) cross-section of Tube B at 50X.

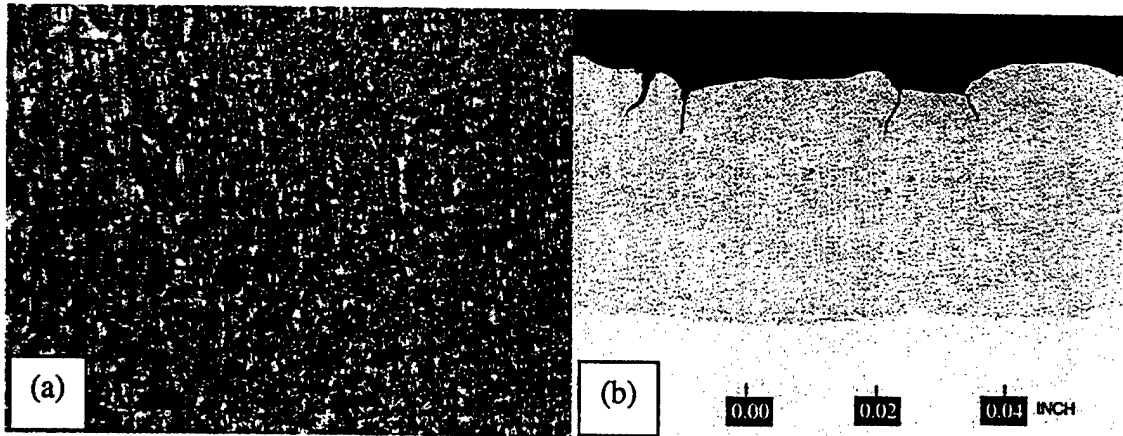
Heat-checking was also evident at the 12- to 14-inch location, along with a general surface roughening as shown in Figure 5a. This roughening is due to the cracking followed by some plastic flow and erosion in this area. This was confirmed by metallographic observations made at this location (Figure 5b).

Figure 5. (a) Surface roughening exhibited at 12 to 14 inches from RFT, and (b) cross-section of Tube B at 50X.

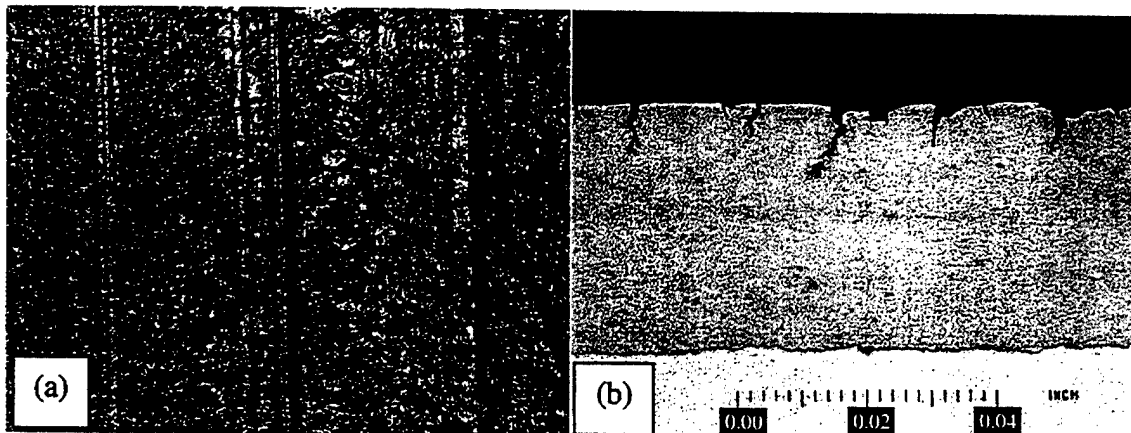
Acute surface roughening was seen in the 18- to 20-inch location (Figure 6). Upon metallographic examination, it was found that cracking also contributed to roughness at this location. Here, the cracks are more finely spaced and shallower than in the locations closer to the breech.

Figure 6. (a) General surface roughening seen at 18 to 20 inches from RFT, and (b) longitudinal cross-section of Tube B at 50X.

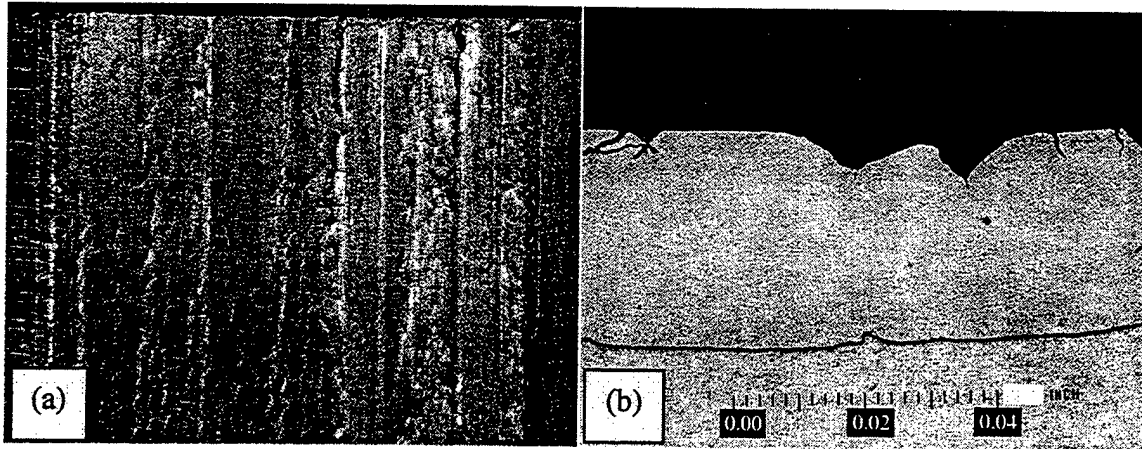
The most dominant feature of the Tube C specimens was severe erosion of the lands up to about 16 inches from RFT (Figures 7 and 8), including near complete obliteration nearest the origin-of-rifling (4- to 8-inch location). Also, seen in the liner of the 4- to 8-inch section were heavy heat-checking and stress patterns similar to those observed in Tube B.

Figure 7. (a) Heat-checking and land erosion at 4 to 8 inches from RFT, and (b) cross-section of Tube C at 50X.

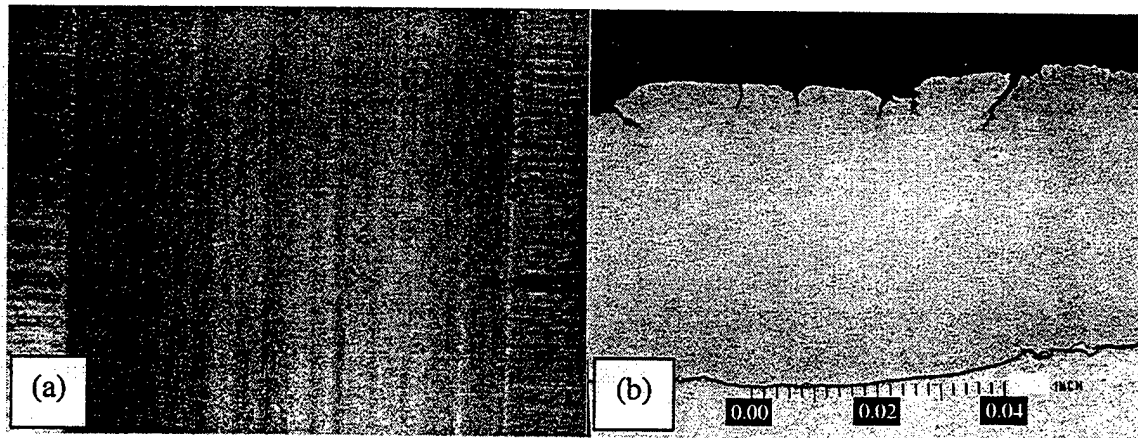
Figure 8. (a) Surface roughening and land erosion at 14 to 16 inches from RFT, and (b) cross-section of Tube C at 50X.

Besides the heavy wear and erosion seen in the main bore in the 14- to 16-inch location, there occurred a general roughening similar to that of Tube B. As with Tube B, this roughening seemed to occur due to cracking of the coating at the surface, followed by deformation and preferential erosion within the cracks (Figure 8b).

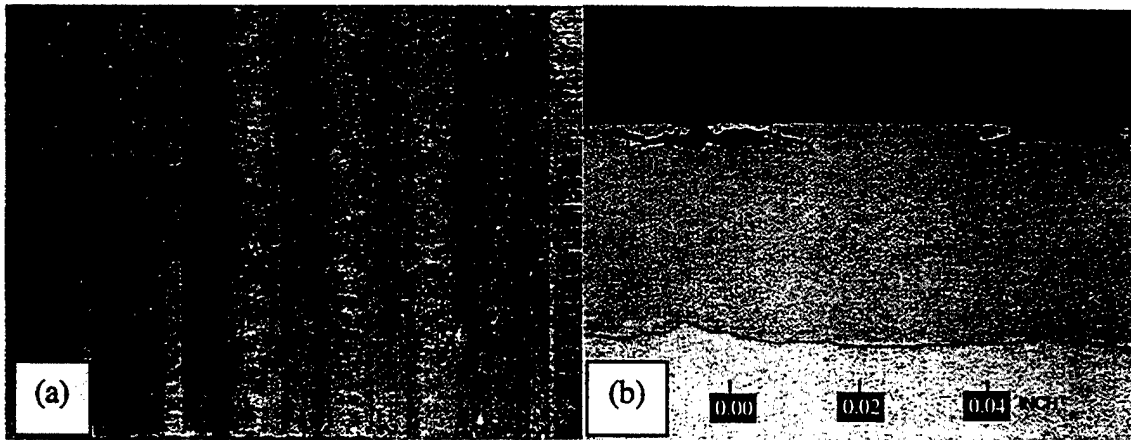
A general roughening of the surface in the 28- to 30-inch location was also observed (Figure 9a). The roughening observed here is due to both cracking and loss of the coating at what appears to be an interfacial phase formed from the dual explosive bonding process (Figure 9b), which will be discussed in a later section.

Figure 9. (a) Wear and surface roughening at 28 to 30 inches from RFT, and (b) longitudinal cross-section of Tube C at 50X.

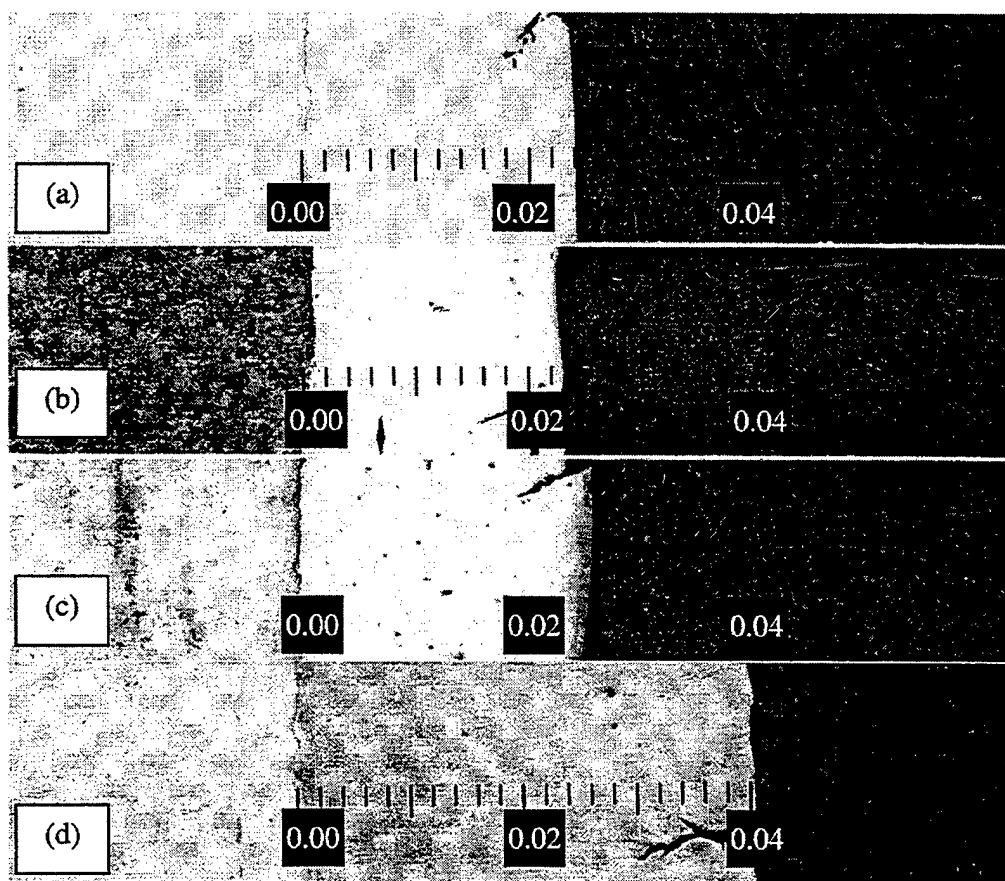
For Tube B, liner thickness measurements were made at 6.5, 10, 14, 20, and 40 inches from RFT in the fired smoothbore specimen. Assuming an initial liner thickness of $\sim 0.040\text{-inch}$, the final thickness measurements of the liner agree well with the bore gauging measurements taken during testing at Aberdeen Proving Ground (ref 1). Figure 11 illustrates several thickness measurements. See Table 1 for complete coating thickness measurements.

Figure 11. Coating thicknesses of Tube B at (a) 6.5, (b) 10, (c) 14, and (d) 20 inches from RFT.

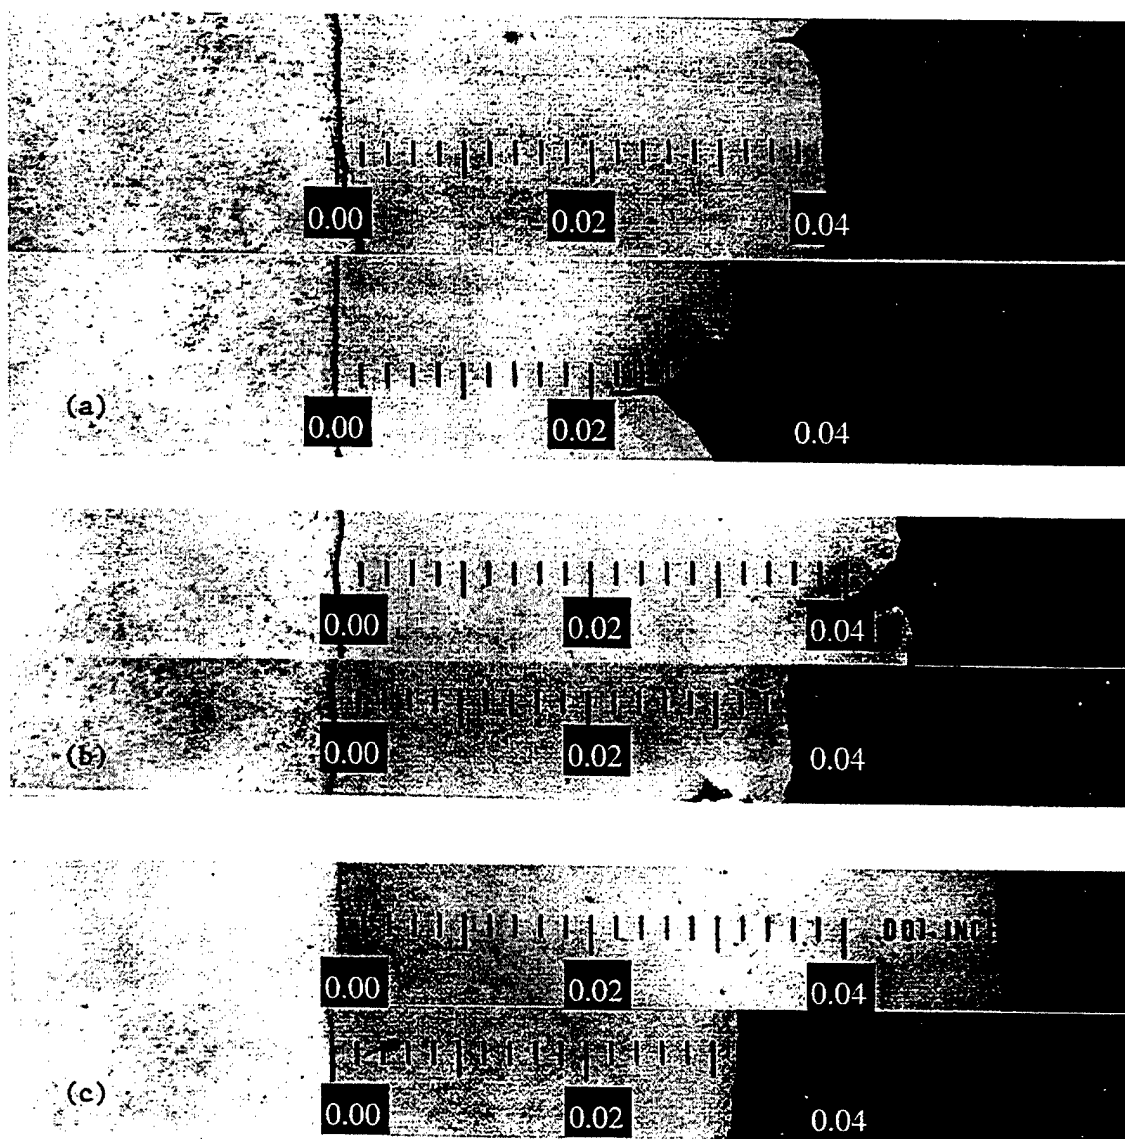
For Tube C, liner thickness measurements were made at 8, 14, 30 and 40 inches from RFT in the fired, no-twist, rifled specimen. At the 8-inch location, the lands were difficult to distinguish from the grooves in the stereomicroscope, as near complete obliteration of the lands had occurred in this location. The liner thickness down bore was much greater than the nominally reported 0.042- and 0.021-inch for land and groove, respectively; but if in fact the liner thickness was indeed 0.060-inch on the lands and 0.037-inch in the grooves, the erosion data compiled at ATC would better correlate to the thickness readings. Figure 12 illustrates several thickness measurements. See Table 1 for complete coating thickness measurements.

Figure 12. Coating thicknesses of Tube C at (a) 8, (b) 16, and (c) 30 inches from RFT.

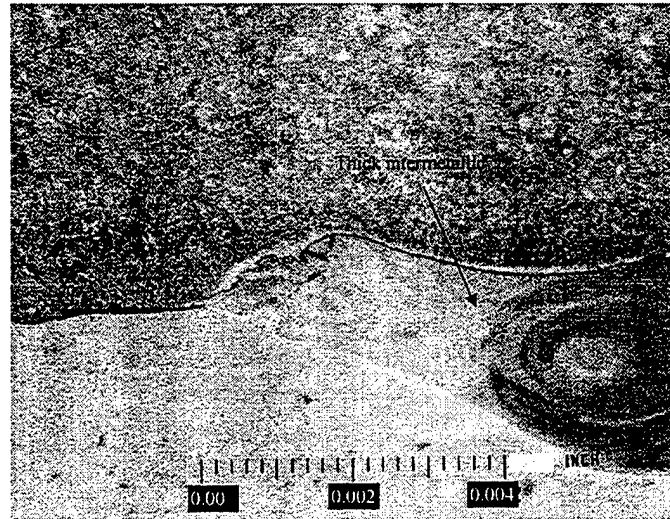
Figure 18. Thick intermetallic and heat-affected zone of Tube C at 30 inches from RFT at 500X.

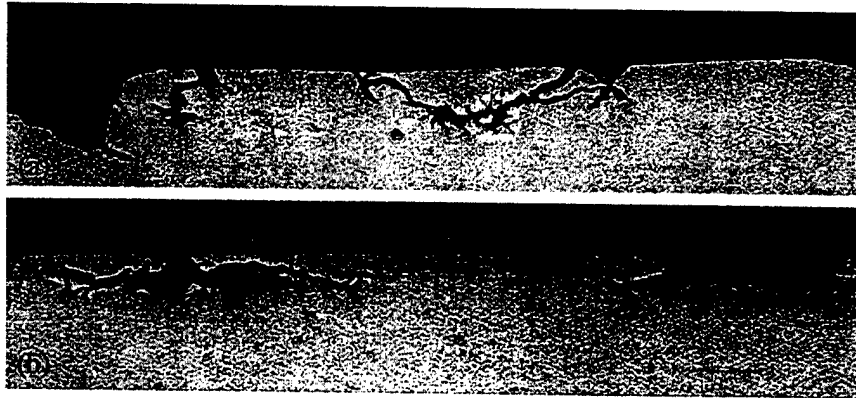
Figure 20. Interphase degradation of Tube C at (a) 8-inch location, and (b) 30-inch location.

The overall erosion characteristics and cracking of Tube C are similar to that of Tube B with the exception of failure of the liner at the interphase tantalum formed by the dual-explosive bonding process. The presence of this phase at an interface near the surface of the liner may lead to extensive premature liner spallation of the lands during firing.

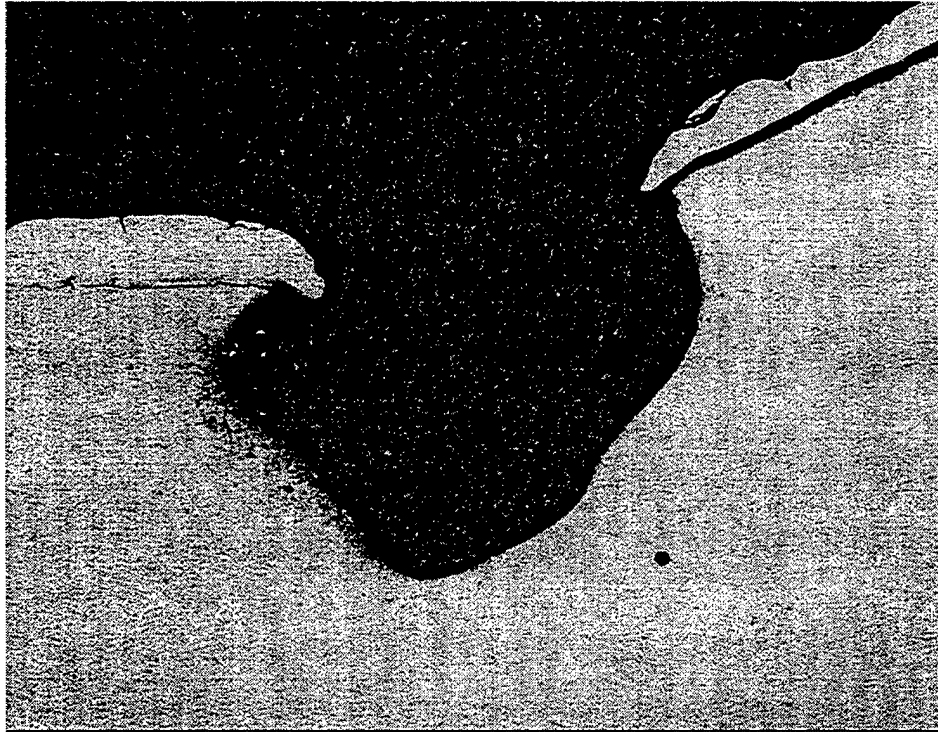
Following sufficient uniform erosion of the liner, the propensity for blow-by of the hot gases due to poor obturation increases. This stage of the erosion process is illustrated by the gas-wash grooves shown in Figures 3 and 4. The inset in Figure 3 is an example of a gas-wash groove following along the heat-check cracking caused by hydrogen embrittlement. The heat-check cracks act as a conduit for the axially oriented gas-wash grooves, thus increasing the speed of this erosion process. Figure 44 is a cross-section taken at the 10-inch from RFT location, and illustrates the severity and dominance of the hot gas erosion at this stage. The final stage of the erosion process exhibited in this tube is in full erosion of the liner at an axially oriented groove and subsequent rapid erosion in the steel as is illustrated in Figure 45.

Figure 45. Severe erosion of underlying steel in Tube B at 8 inches from RFT at 15X.
